## **DURABILITY IMPROVEMENT OF A WISHBONE BUSH FOR A PASSENGER VEHICLE**

### **ABSTRACT**

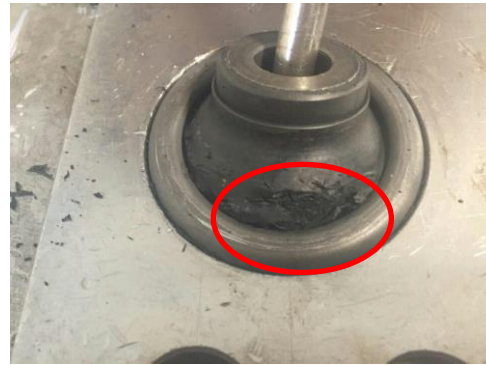
A picture of the failure part is given in Figure 2. This picture was taken after 100K cycles of the durability test. It is obviously seen that the part has physical damages, cracks and even some elastomer particles tore off the main body.

Figure 2: Failed part.

FEM results shown on figures 5, 6 and 7 are in full agreement with the physical failures shown in figures 2 and 3. The hot spots determined by the FEM analyses are actually the same places where the elastomer bushes fail.

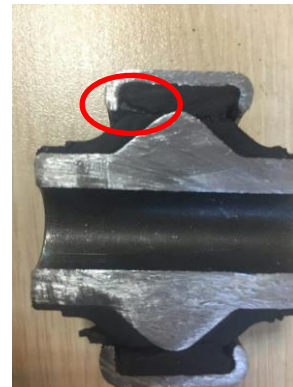
To see the internal structure of the failed part, it is cross-cut and the view of its cross section is given in Figure 3.

Figure 3: Cross-section of failed part.

According to this cross section it can be said that the physical damage started at the bulge surface or a place near the bulge surface of the elastomer body and penetrated inwards.

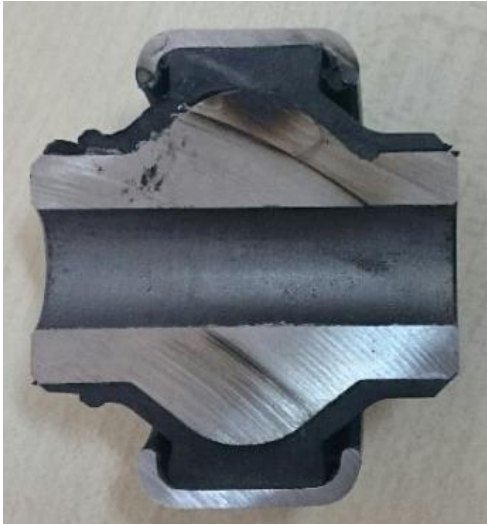
A number of prototypes was produced to perform the same durability test described in section 4 and three different samples are undergone through the durability test. It was seen that, the new design proposal survived even 1,1 million cycles without any unacceptable physical damage. The picture of a sample after the durability test can be seen in Figure 13.

Figure 13: Picture of the new design after 1,1 million cycles of durability test.
